# **Ryan Chouest daily data transmission and report**

***Period covered: 1034 07/17/2010- 0934 07/18/2010***

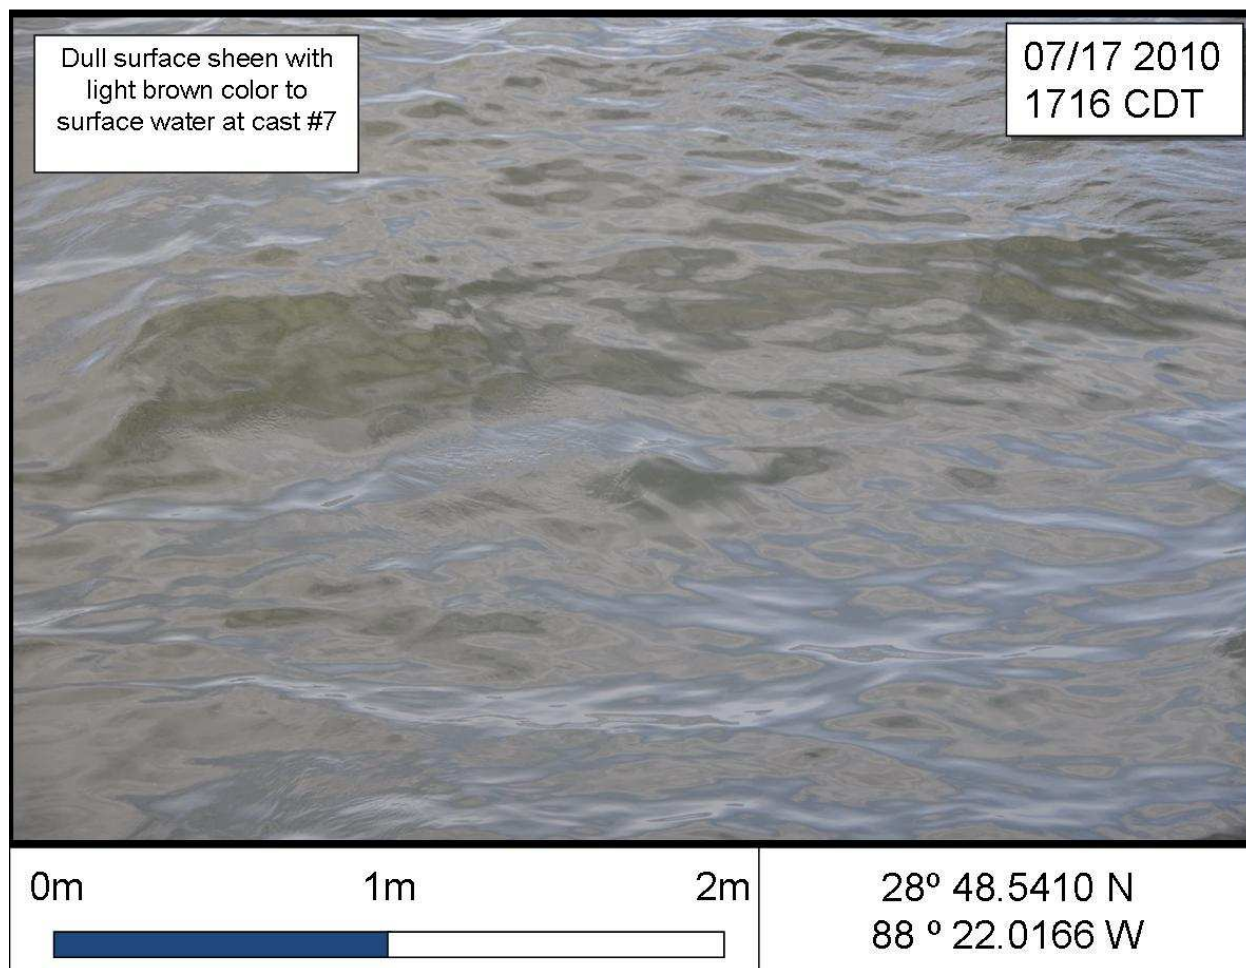
Surface sheens were observed throughout the surveyed route (Photographs 1-2). A contrast in the color of the seawater was noted at Cast station #7. Water at that location appeared to be browner and greener than the usual deep blue color. In addition, Greenish colored water was observed as we were sailing away from Cast #7 and may be a result of algal blooms in the upper photic zone (Photograph 3).

Photograph 1 Dull surface sheen in a brown colored water located at cast #7.

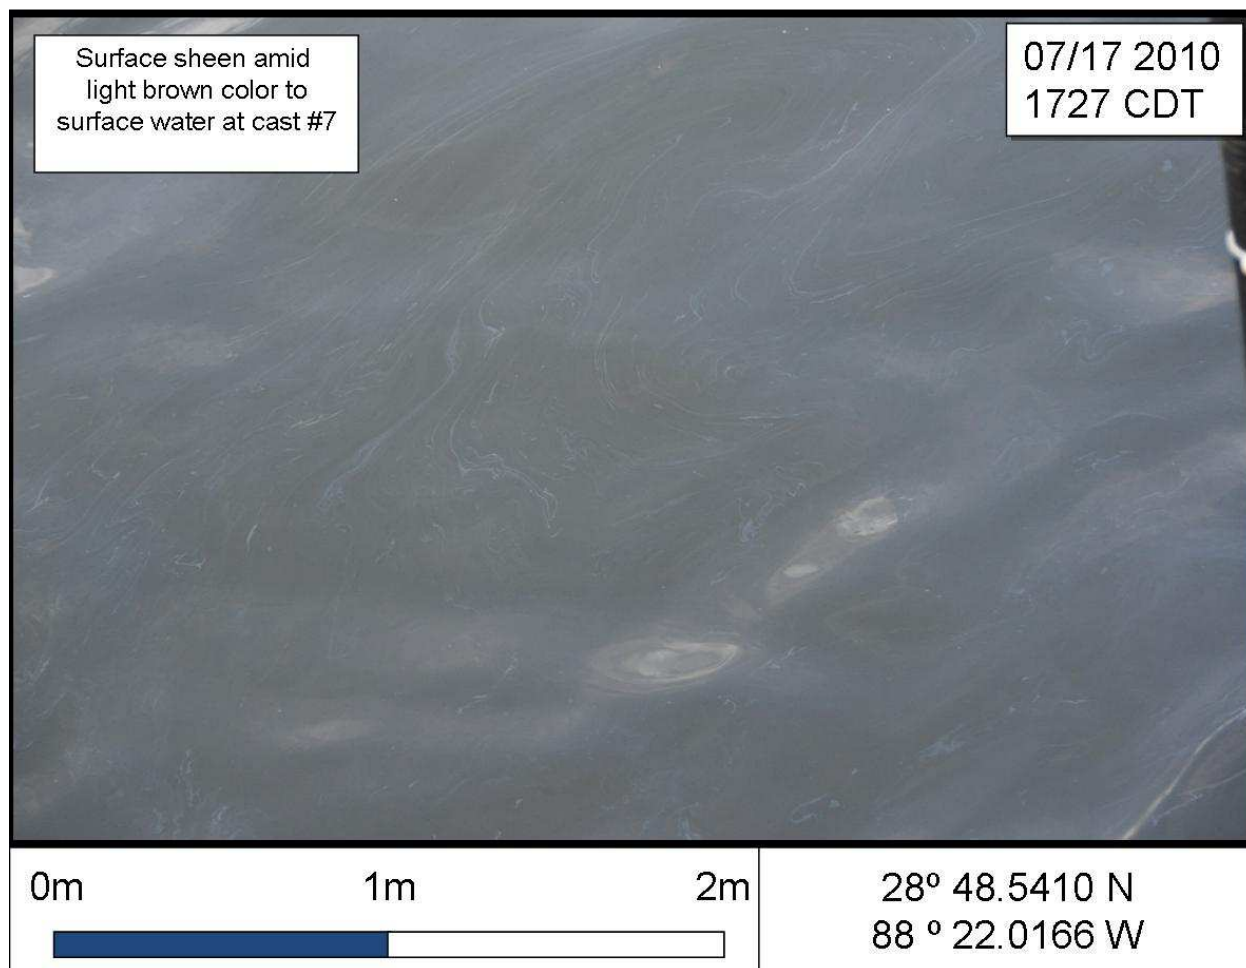
Photograph 2. Surface sheen in a brown colored water located at cast #7.

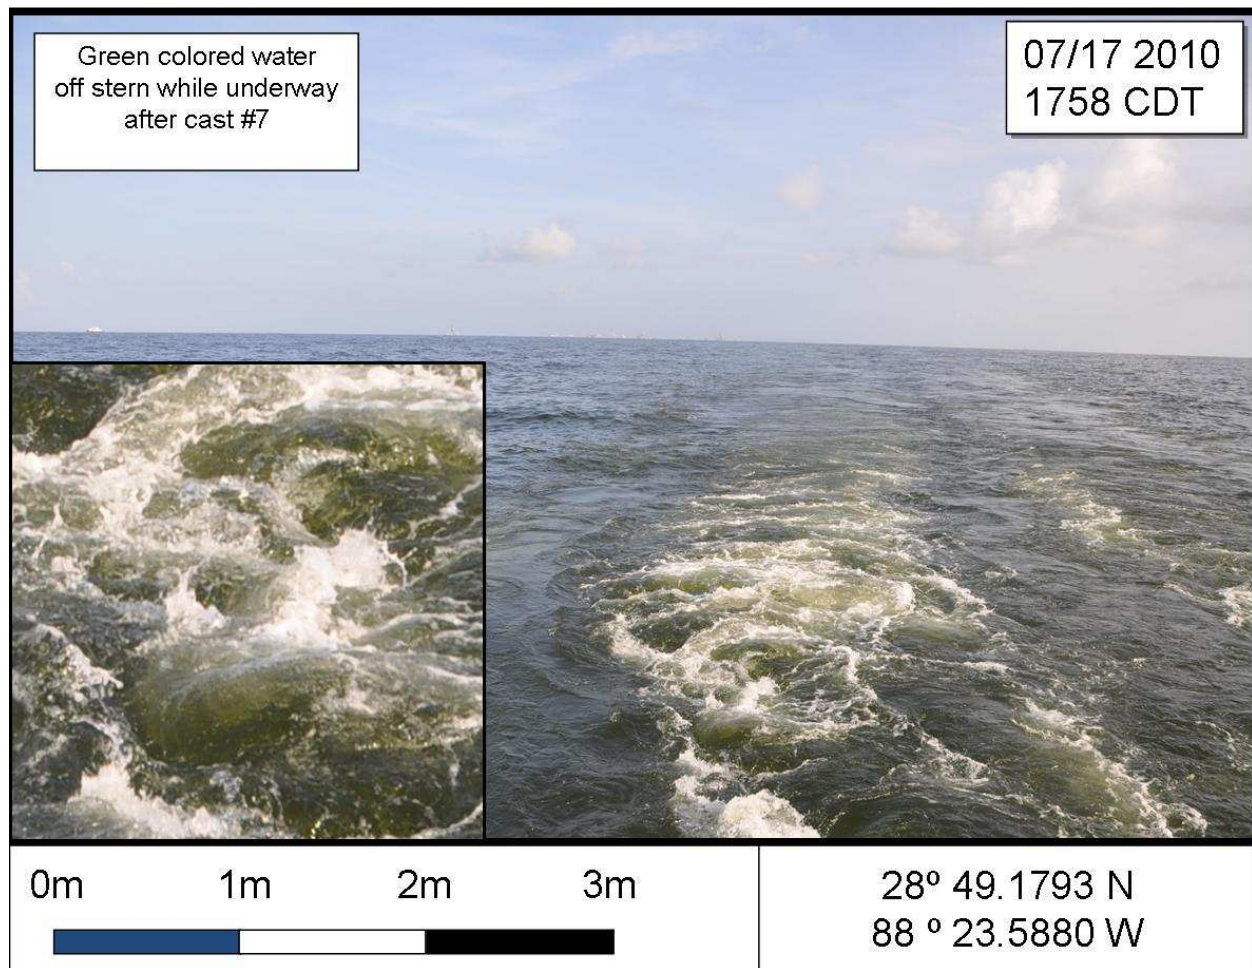
Photograph 3. Greenish colored water observed off the stern while underway after taking cast #7. The color may be due to a combination of green, golden-brown (diatoms), and/or yellow-green algal blooms in the upper photic zone.
